Power Take-Off (PTO) Safety

Dennis J. Murphy, Professor of Agricultural Engineering

The Power Take-Off (PTO) shaft is an efficient means of transferring mechanical power between farm tractors and implements. This power transfer system helped to revolutionize North American agriculture during the 1930s. It is also one of the oldest and most persistent hazards associated with farm machinery. This fact sheet discusses several aspects of PTO safety.

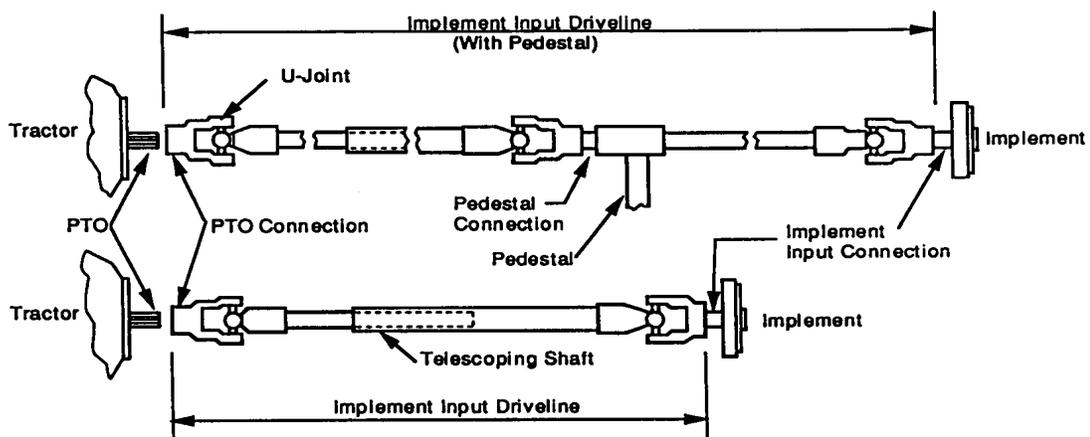
Figure 1 is a diagram of component parts of an implement PTO. Two typical PTO system arrangements are shown. These drawings are helpful for understanding PTO hazards, guarding, and injuries. The top drawing is of a PTO system involving a pedestal connection, such as is found on many types of pulled machinery (hay balers, forage choppers, large rotary mowers, etc.). The lower drawing is of a PTO system where the implement's input driveline connects directly to the tractor PTO stub. Examples of this type of connection include three-point hitch mounted equipment (post hole diggers, small rotary mowers, etc.) and augers.

Figure 1. The major components of PTO systems

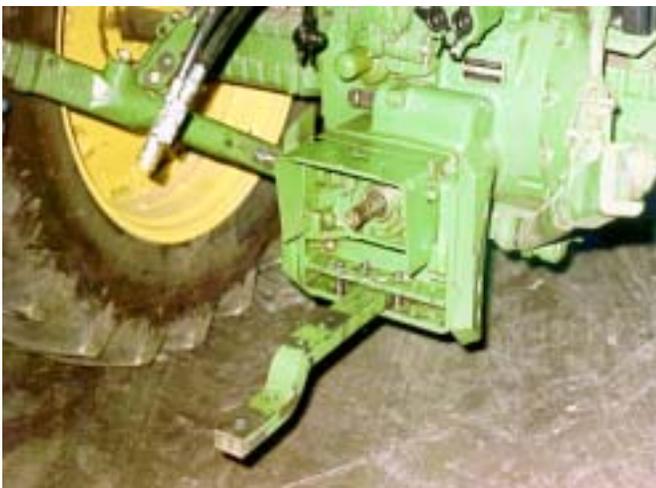
Figure 2. A master shield covering the tractor PTO stub.

Guarding a PTO system includes a “master shield” for the tractor PTO stub and connection end of the implement input driveline (IID) shaft, an integral-journal shield which guards the IID shaft, and an implement input connection (IIC) shield on the implement. The PTO master shield is attached to the tractor and extends over and around the PTO stub on three sides (Figure 2). This shield is designed to offer protection from the PTO stub and the front joint of the drive shaft of the connected machine. Many tractors, particularly older tractors, may no longer have PTO master shields. Master shields are removed or are missing from tractors for several reasons including: damaged shields that are never replaced; shields removed for convenience of attaching machine drive shafts; shields removed out of necessity for attaching machine drive shafts; and shields missing when used tractors are sold or traded.

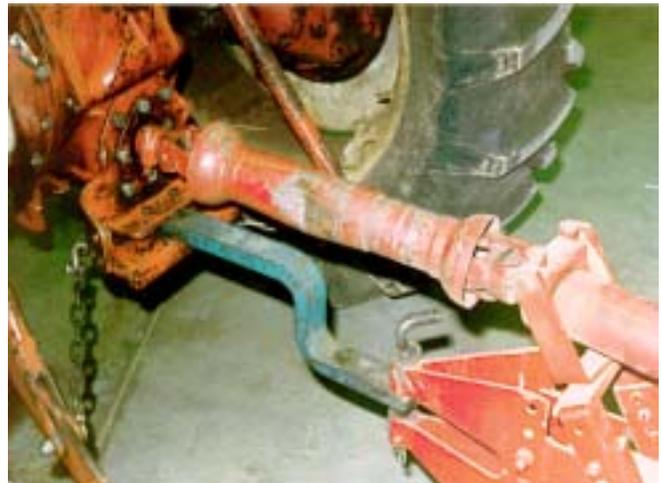
Figure 3. A bent shaft guard offers no protection from a spinning PTO shaft. Also notice the missing master shield and the inadequate guarding of the universal joint near the PTO pedestal. Missing shields and poor maintenance practices often seem to go hand-in-hand.

There are many more injuries associated with the IID shaft than with the PTO stub. As noted earlier, machine drive shaft guards are often missing. This occurs for the same reasons tractor master shields are often missing. A IID shaft guard completely encloses the shaft, and may be constructed of plastic or metal. These tube like guards are mounted on bearings so the guard rotates with the shaft but will stop spinning when a person comes into contact with the guard. Some newer machines have driveline guards with a small chain attached to a non-rotating part of the machine to keep the shield from spinning. The most important thing to remember about a spinning IID shaft guard is that if the guard becomes damaged so that it cannot rotate independent of the IID shaft, its effectiveness as a guard is lost. In other words, it becomes as hazardous as an unguarded shaft (Figure 3). This is why it is important to always spin the IID shaft guard after attaching the PTO to the tractor (the tractor should be shut off), or before starting the tractor if the attachment has already been made. This is the best way to make sure that the IID shaft guard is really offering you protection.
